TO : OUR VALUED DISTRIBUTORS
FROM: Alex Tsen –Fall Protection Project Manager
DATE: September 3, 2008
SUBJECT: FP541 Rope Grab Clinch Nut Product Advisory

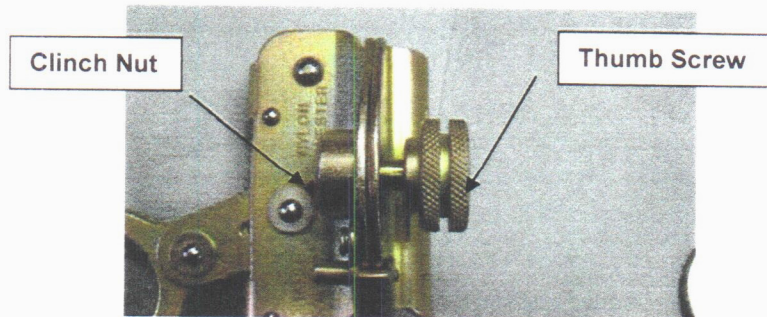
Figure 1

Initially, repetitive impact on the unit can cause the locking thumb screw to back away from the clinch nut (Figure 1). Once this occurs, additional repetitive impact on the end of the screw can cause the clinch nut to dislodge from the housing of the rope grab (Figure 2). If there is further continuous impact on the unit after the clinch nut is dislodged, the clinch nut may eventually become completely dislodged from the locking thumb screw (Figure 3). Without the positive connection between the clinch nut and thumb screw, the rope grab will not perform properly in the event of a fall which can lead to serious injury or death.

To ensure that this does not happen in your workplace please identify areas where this unit may be exposed to repetitive impact and notify your personnel of this possibility. Please ensure that the thumb screw is always tightly secured to the clinch nut and that it is periodically checked to ensure that the tight positive connection still exists. More frequent inspections may be required for applications where the unit is exposed to high repetitive impact of the unit.

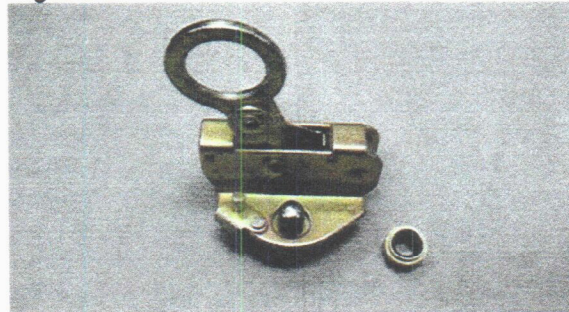
Figure 3

While a rope grab will continue to function as intended until the clinch nut is dislodged completely from the unit (Figure 3), we recommend that in an abundance of caution, you remove any rope grab from service that begins to demonstrate a separation between the thumb screw and clinch nut. (Figure 2).

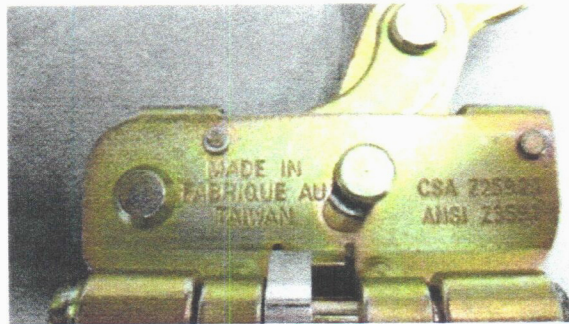
Figure 4

North safety has identified the problem only specific to FP541 series rope grabs that have a stamp on the housing that states "Made In Fabrique Au Taiwan" (Figure 4). North Safety is in the process of correcting the issue and we are confident that this will be rectified in a timely manner.
